# **Northwest Brook Restoration Project: In-stream Restoration Techniques**

**Keelan Drumm, Stella Gale and Ryan Haley**

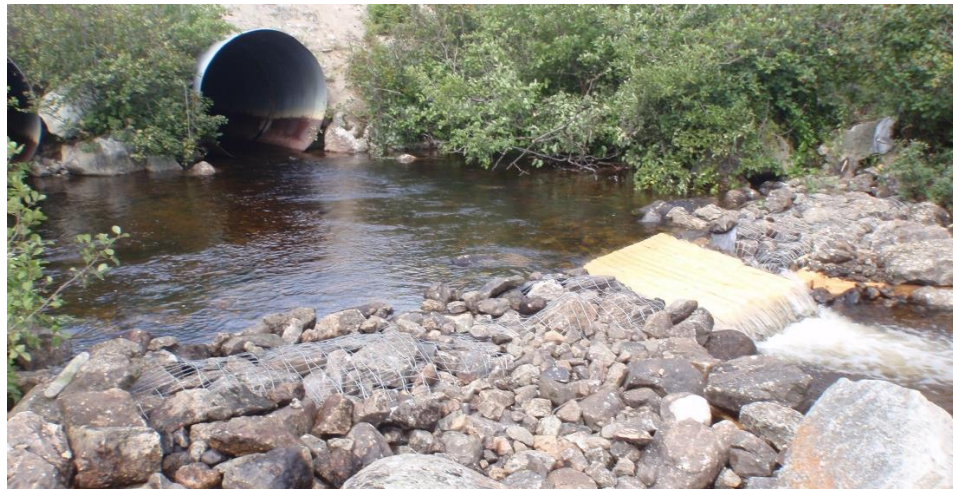
Passing through a culvert can be stressful for fish and this stress may be increased by a lack of resting pools, high stream velocities and the presence of an outlet drop. The two culverts present underneath Highway 320 at Northwest Brook were enhanced by mitigating these three variables. The culvert outlets were higher than the water level, causing low water levels through the culverts as well as an outlet drop which reduced the ability for fish to migrate upstream. In an effort to mitigate these issues, IBEC installed a low head weir downstream of the culverts to create a wetted lip, which deepened the water level through the culverts and enhanced the resting pools on both sides of the culvert.

*Figure 1: Low head weir located downstream of Highway 320.*

The low head weir, as shown above, has a low profile design which allows for the water level to be raised through the culverts while limiting the pressure placed against the structure during high water levels which frequently occur during the spring freshet. Constructed in accordance with the drawing below, gabion baskets were used to hold rocks, stabilizing the structure and increasing its lifespan. Geotextile fabric was placed along the upstream side of the weir and along the streambed to capture suspended sediment, decreasing the permeability of the structure over time. The fabric was then covered by a rock ramp to prevent the creation of an undercut and to push ice and debris over the weir. Wooden beams were placed on the

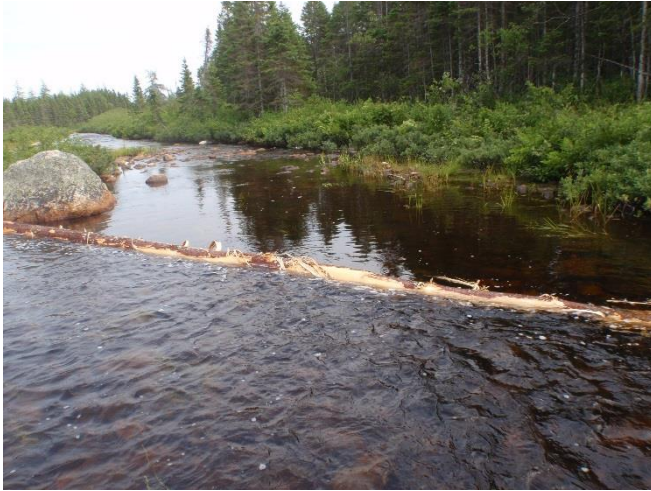
Low water levels are a concern in numerous sections along Northwest Brook, this is due to several anabranches and severely eroded stream banks causing the flow of water to disperse from the main channel. Natural stream widths in numerous watersheds throughout the Bonavista North Region have been altered by events such as a great fire which removed much of the riparian vegetation and the use of logging dams which altered the water flow to move timber downstream.

*Figure 3: Timber support*

In an effort to mitigate low water levels and enhance the naturalization of the stream width, IBEC installed multiple deflectors (Figures 3 & 4) to divert the flow of water into the natural channel to maintain adequate water levels for fish passage. The type of material used was determined by multiple factors including structure size, location, water level and velocity. In locations with low water levels and limited velocity, rock deflectors were used with the largest rocks being placed along the bottom upstream portion of the structure. In areas with high water velocity or high water levels, increased pressure is placed against the structure. To offset this increased pressure, timber was laid across the downstream side of the structure and braced by large boulders as well as fastened to rebar which was driven a minimum of three feet into the streambed. The deflectors consist mostly of rock with Geotextile fabric draped over the upstream side and along the streambed. This was done to decrease the permeability and catch suspended

sediment, allowing for the gaps between the rocks to be filled and the structure to become more stable over time. The Geotextile fabric was then covered by a rock ramp to prevent the formation of an undercut and allow for peak flows, ice and debris to pass over unimpeded.

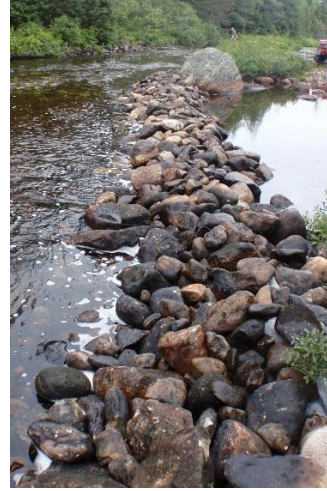
*Figure 4: Tree deflector*
